# SAFE PRACTICES *in Patient Care*

Helping to promote a culture of safety

### Luer connectors

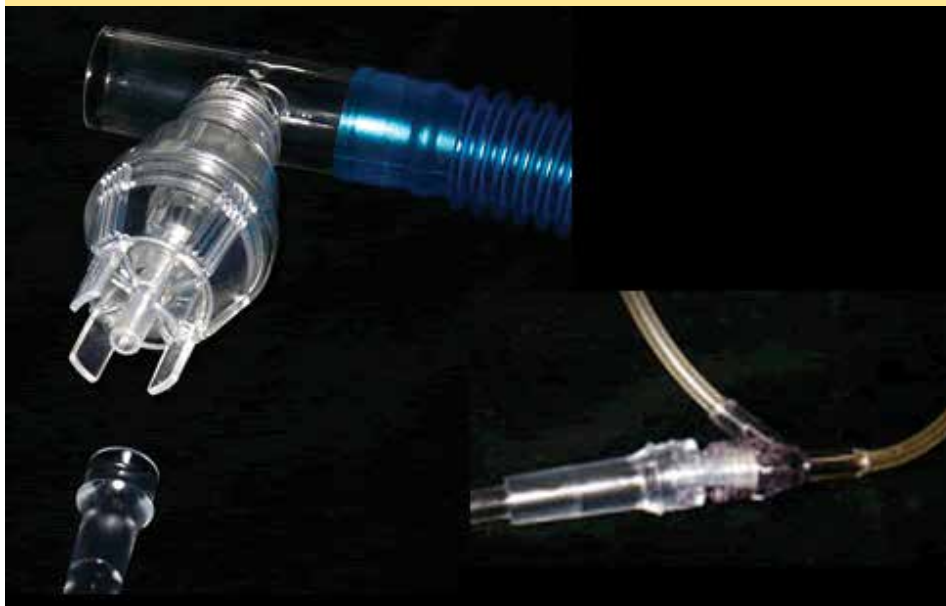
### **Tubing Misconnections**

**Tube delivering oxygen fell off nebulizer**

**The oxygen tubing was connected to a Needleless Access System IV tubing Y-site**
